A FISHWAY THAT SHAD ASCEND

SPECIAL SCIENTIFIC REPORT: FISHERIES No. 65

By Gerald B. Collins
Fishery Biologist

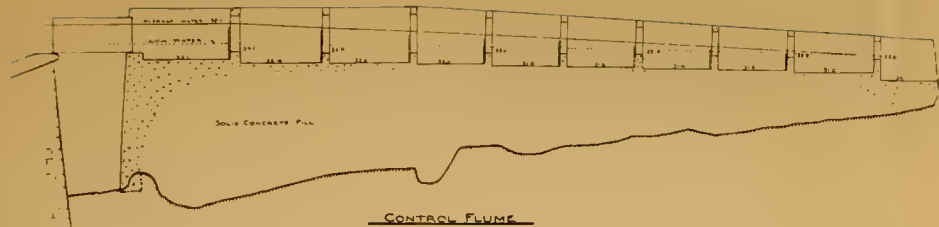
SECTION SHOWING FLASH-BOARD METHOD OF REGULATING FLOW IN FISHWAY

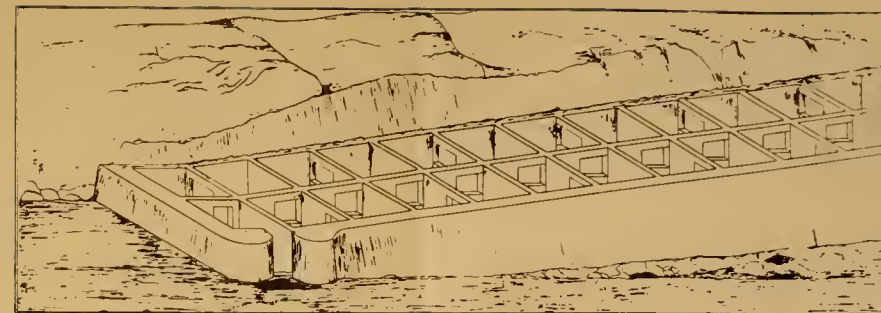
SKETCH OF LOWER END OF FISHWAY

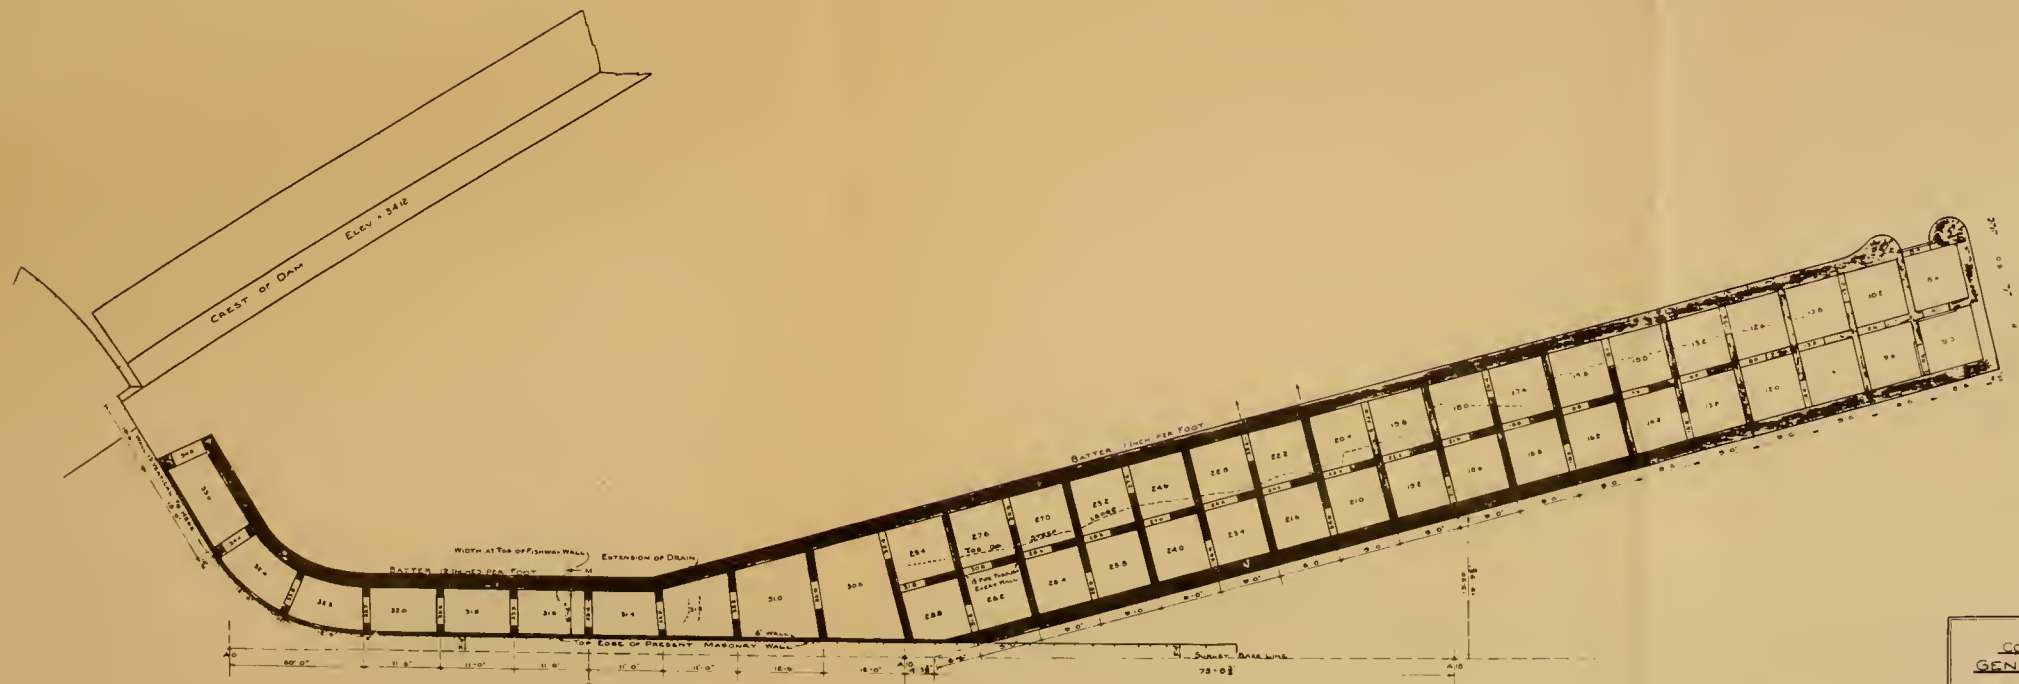
Figure 1. -- Plan of Lawrence Fishway
Note that original weirs were 4 feet in width.
(Modified in 1937).

COMMONWEALTH OF MASSACHUSETTS
COMMISSION ON FISHERIES AND GAME
GENERAL PLAN OF PROPOSED FISHWAY
AT DAM OF THE
ESSEX COMPANY
LAWRENCE, MASS.
SCALE 1 INCH = 5 FEET
B. B. HAYWARD, CIVIL ENGINEER
NOVEMBER 30, 1918
TAYLOR, MASS.

In 1936, the fishway was severely damaged by flood waters. The following year major repairs were undertaken and at the same time several modifications were made. The most important of these changes was an alteration of the weirs. In crossing the original weirs which were 4 ft. wide (Figures 1 and 2), the deep-bodied shad sometimes had difficulty because of the relative shallowness of the water (from 2 in. to 6 in. in depth). Fish examined in the upper part of the fishway were frequently found to be badly scraped. To remedy this condition, in 1937 notched weirs were constructed on top of the original weirs. Each of the notches (Figure 11) is 2 ft. wide at the top, 1 ft. wide at the bottom and 1 ft. deep. The floor of each notch is sloped at an angle of 30°. The top of the notched weir is 1.5 ft. above the original weir. This modification not only resulted in a deeper flow across the weir but it raised the average depth of the water in the pools when the fishway was in operation from less than 3 ft. to more than 4 ft.

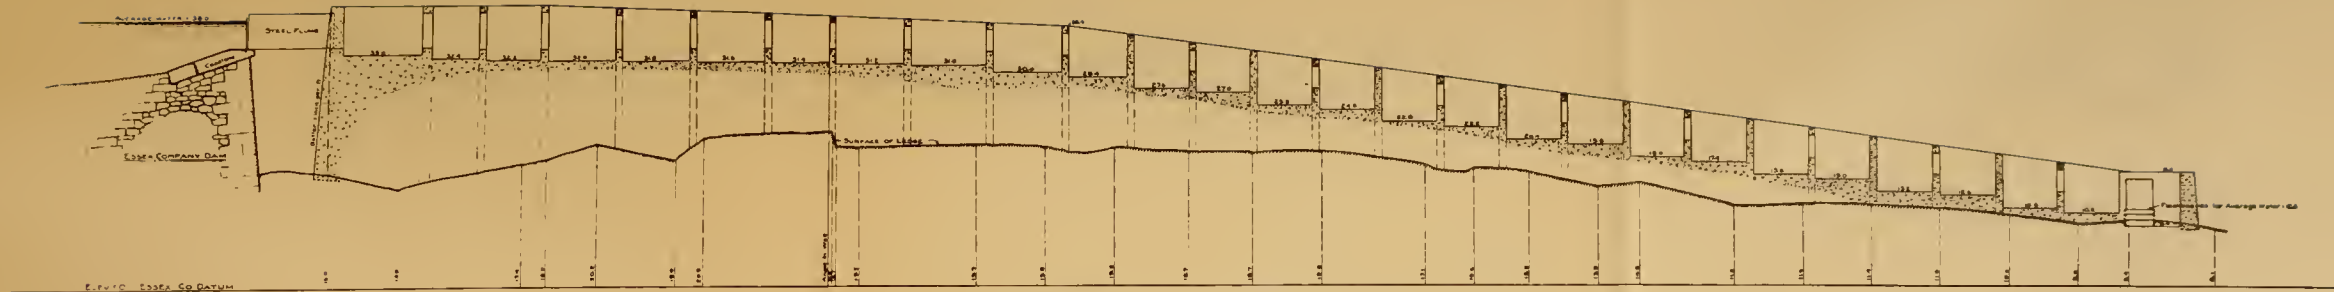
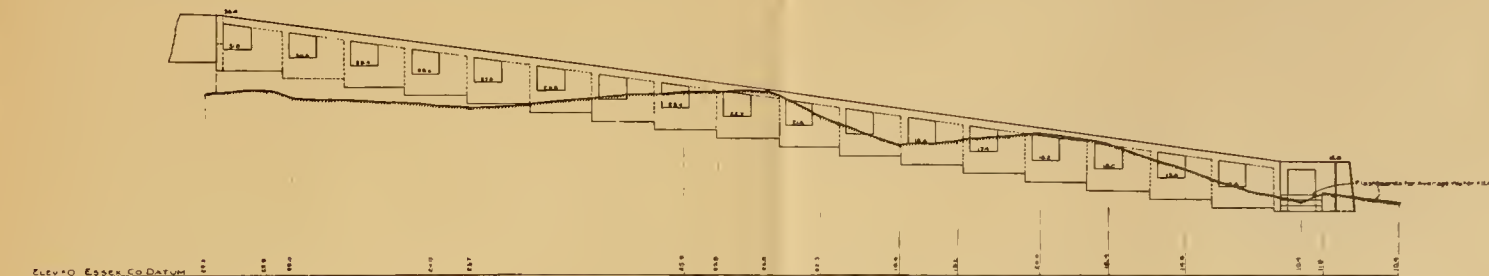
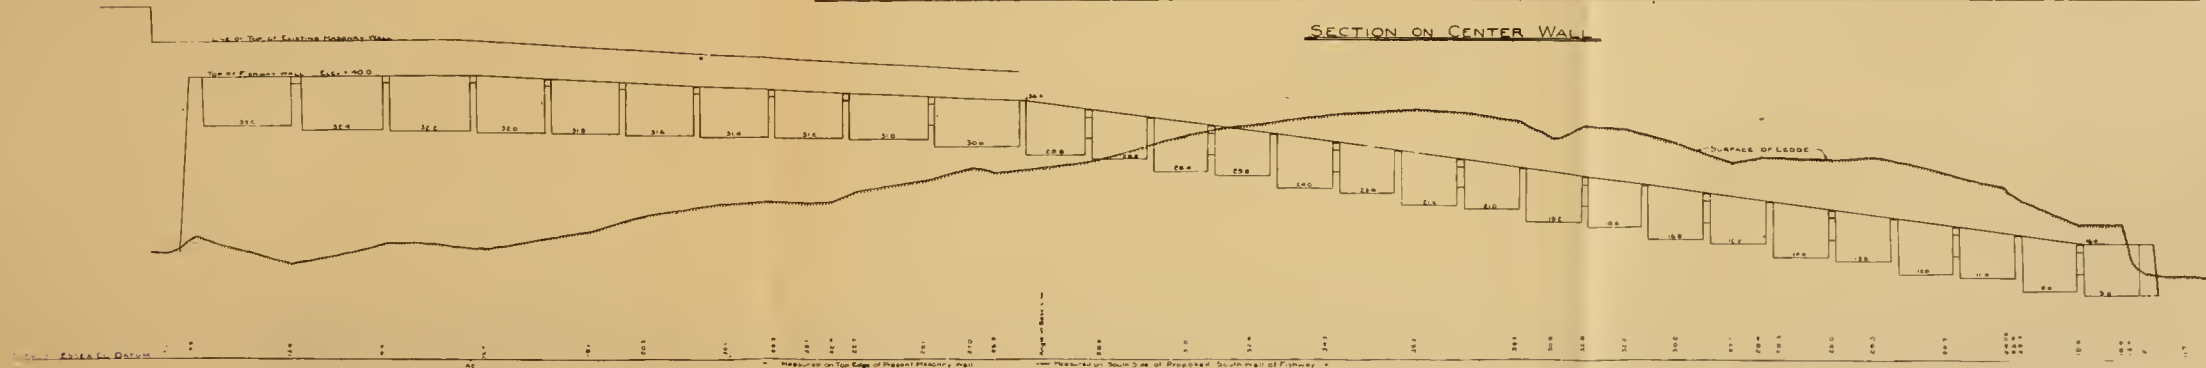
PROFILE OF NORTH WALL OF FISHWAY

SECTION ON CENTER WALL

PROFILE OF SOUTH WALL OF FISHWAY

Figure 2. -- Profile of Lawrence Fishway
Note lower flashboards. These proved difficult to maintain. (Modified in 1937).

Because the shad did not enter the fishway under high tailwater conditions (tailwater elevations of 15 ft. above mean sea level or greater) in 1937 an opening was cut in the side of one of the lower pools (Figures 4 and 9) to allow the fish to enter the fishway without passing through the turbulent area (Figure 7) near the entrance.^{2/} Another change that was made in 1937 was the replacement of the adjustable plank weirs in the lower 3 pools ("flashboards" of Figure 2) with notched concrete weirs.

The characteristics of flow in the fishway entrance and in the lowest two pools ^{5/} were studied under a variety of tailwater conditions (Figures 13, 14, 15). Flow patterns made with both the original "flashboard" arrangement (Figure 2) and with the notched weirs installed in 1937 showed only minor differences because the weirs are flooded throughout most of the range of tailwater elevations at which shad enter the fishway. The flow in the lowest pool and through the entrance was remarkably uniform and lacking in turbulence. Velocities through the entrance ranged from a maximum of 2.6 ft/sec. at a tailwater elevation 11 ft. (above mean sea level) to less than 0.5 ft/sec. at a tailwater elevation of 14.5 ft. (above mean sea level). The large curved reinforcements on each side of the entrance created an area with lower velocities just outside the entrance (Figures 13, 14, 15).

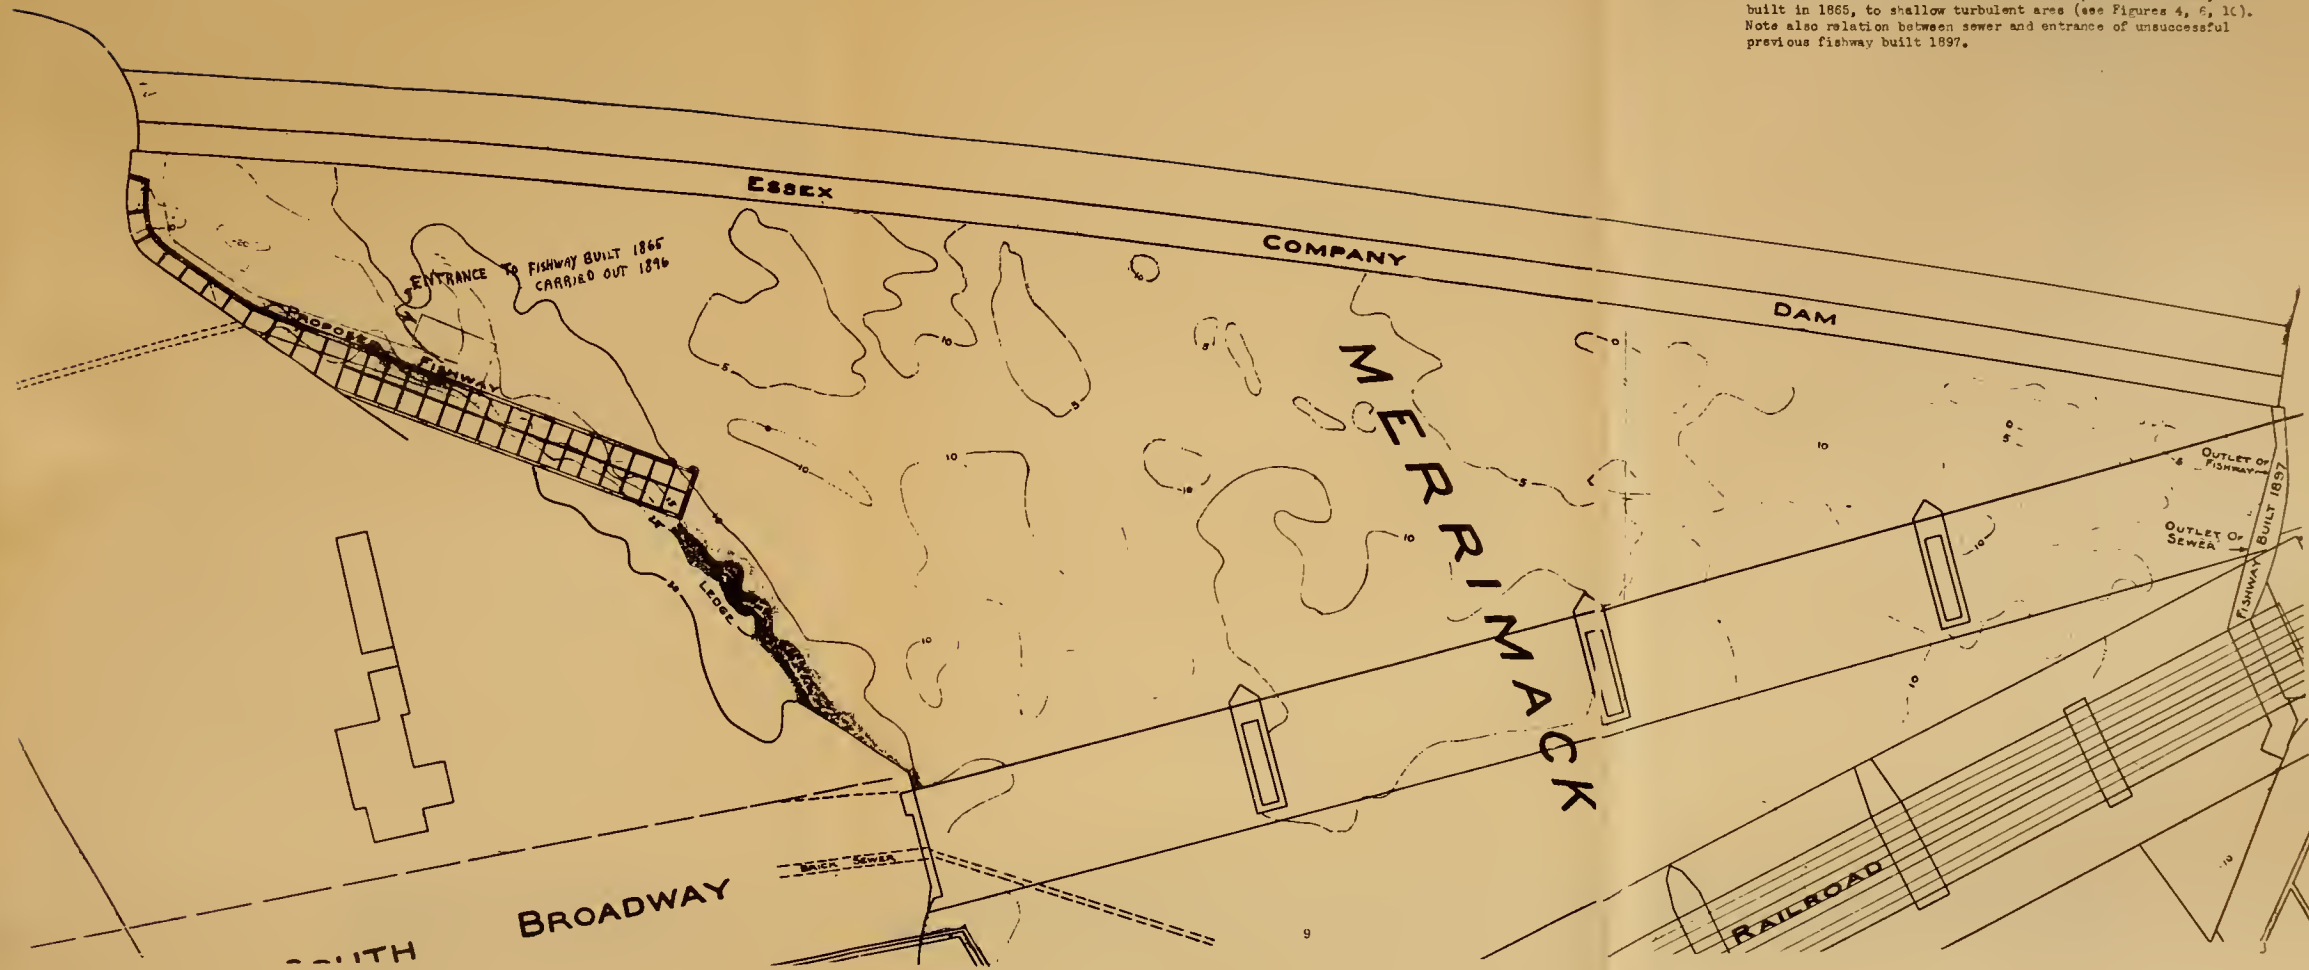
Figure 3. -- Location of Lawrence Fishway
 Note relation of fishway entrance to river channel and to shore.
 Note relation of entrance of unsuccessful previous fishway,
 built in 1865, to shallow turbulent area (see Figures 4, 6, 1C).
 Note also relation between sewer and entrance of unsuccessful
 previous fishway built 1897.

The entrance to the fishway is 4 ft. in width and is located at the edge of one of the main channels (Figure 3). In a normal year the new wood used for flashboards on the crest of the dam is placed on the north side of the dam. During the winter the weaker boards on the south side of the dam frequently become damaged by ice and are washed out so that in the spring the flow is concentrated in the channel next to the fishway entrance. Large curved reinforcements on each side of the entrance (Figure 1), probably designed to strengthen the fishway structure at the opening, may actually be responsible for a large measure of the fishway's success with shad.

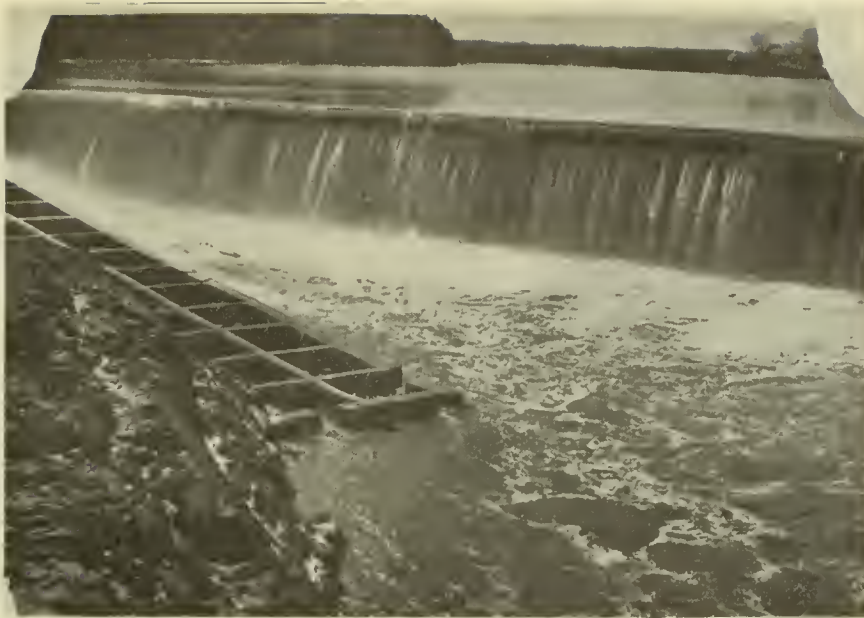
Figure 4.-- General View of Lawrence Fishway

Tailwater Elevation 14.5 ft. (above mean sea level). This water level probably represents the maximum tailwater level under which shad enter the ladder. Water velocity through fishway entrance about 0.3 ft/sec. Note opening (3 ft. x 3 ft.) cut in side by second pool in 1937. There is no evidence of this opening ever being used.

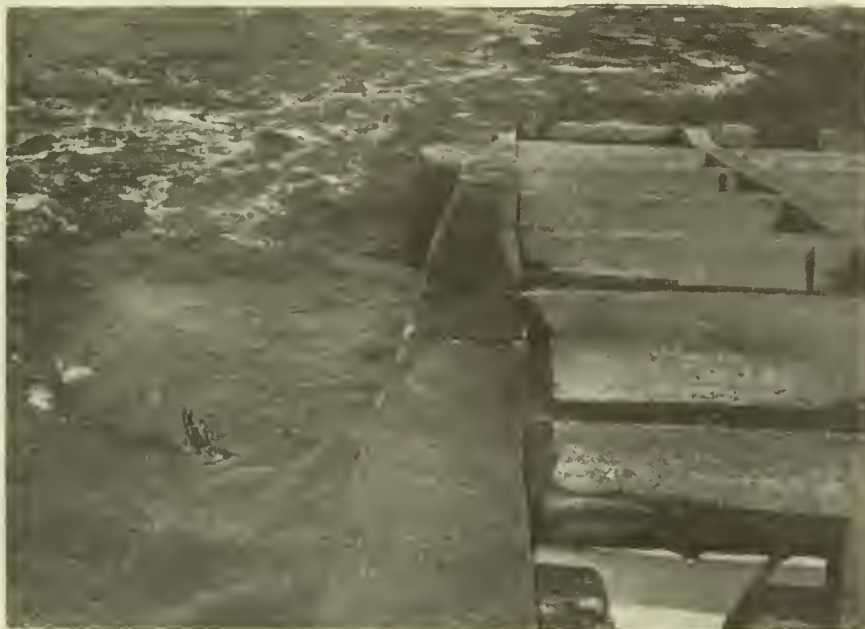
Figure 5.-- Water Conditions at Fishway Entrance

Tailwater Elevation 14.5 ft. (above mean sea level). Note the large rock in the left foreground. The extreme turbulence of the water to the left of this rock can be seen in Figure 4 above.

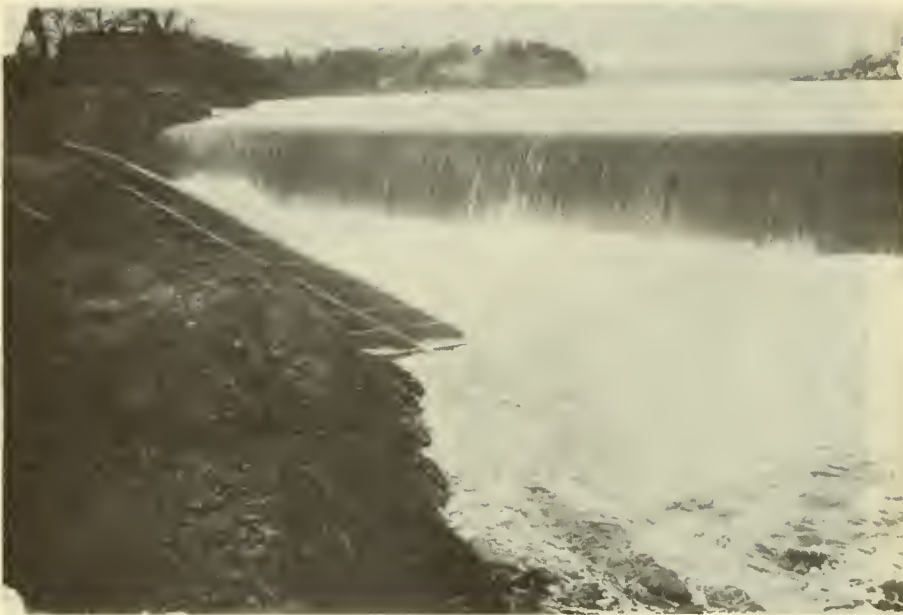
Figure 6.-- General View of Lawrence Fishway
Tailwater Elevation 17 ft. (above mean sea level) Note extreme turbulence. Shad do not approach the fishway under these water conditions.

The probable maximum water level at which shad enter is at a tailwater elevation of 14.5 ft. (above mean sea level). At this water level the velocity of the water through the entrance is reduced to about 0.3 ft./sec. and water flows through the opening in the wall of the second pool at about 1 ft./sec. Above this tailwater level the water in the vicinity of the fishway entrance becomes excessively turbulent (Figure 6).

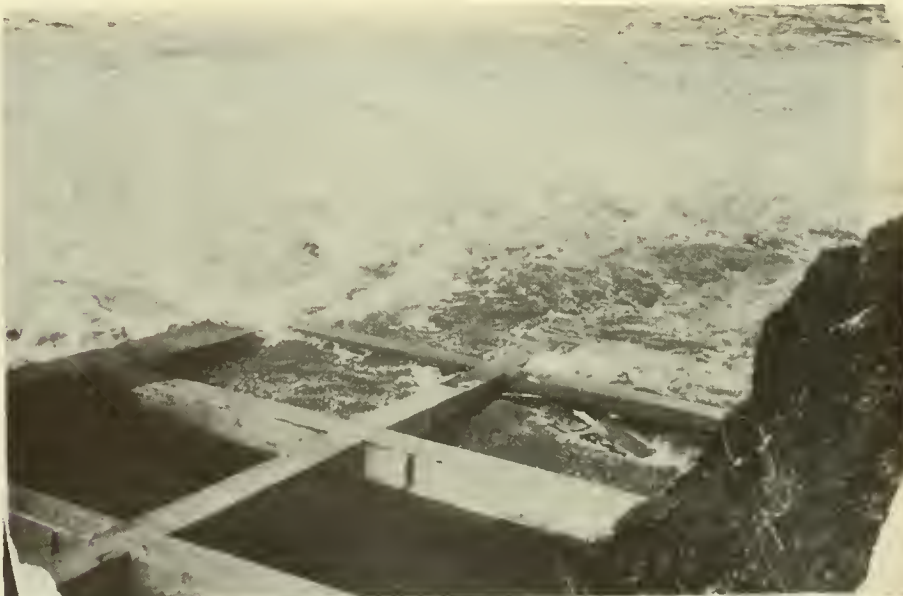
Figure 7.-- Flooded Fishway Entrance
Tailwater Elevation 17 ft. (above mean sea level).

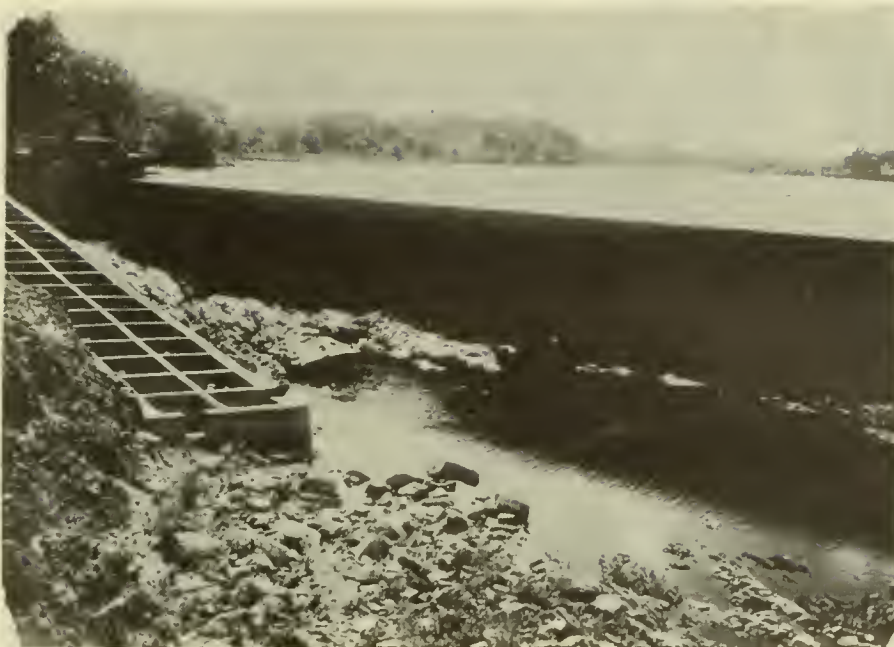
Figure 8.-- General View of Lawrence Fishway
Tailwater Elevation 7 ft. (above mean sea level) No water over spill-
way. Shad are unable to reach the fishway under these conditions.

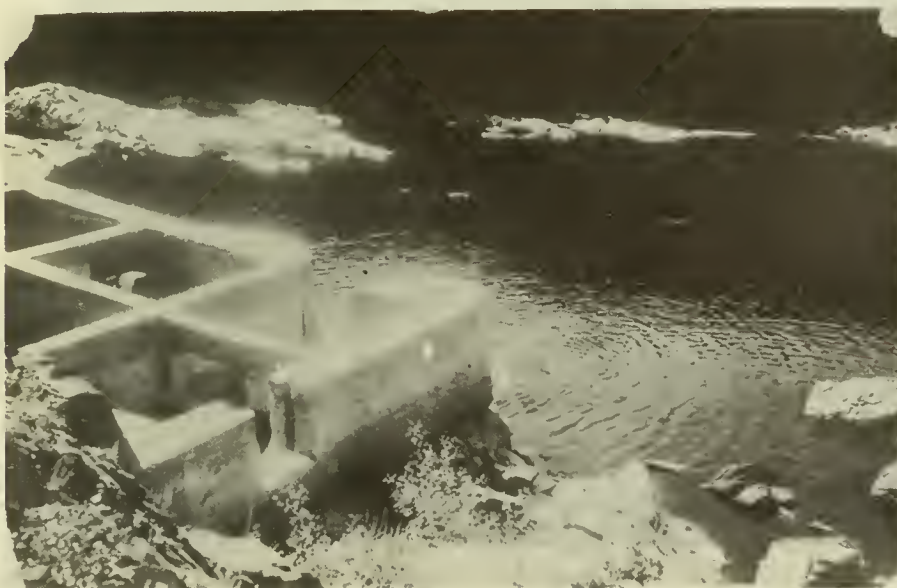
Figure 9.-- Close-up of Fishway Entrance
Tailwater Elevation 7 ft. (above mean sea level)

^{5/} The opening in the side of the second pool (Figure 9) was not made in the model. It is not involved at tailwater elevations of 13 ft. (above mean sea level) or lower and it has very little influence upon the pattern of flow until tailwater elevations exceed 13.5 ft. (above mean sea level). Its main effect is a reduction in the velocity of the flow through the fishway entrance.

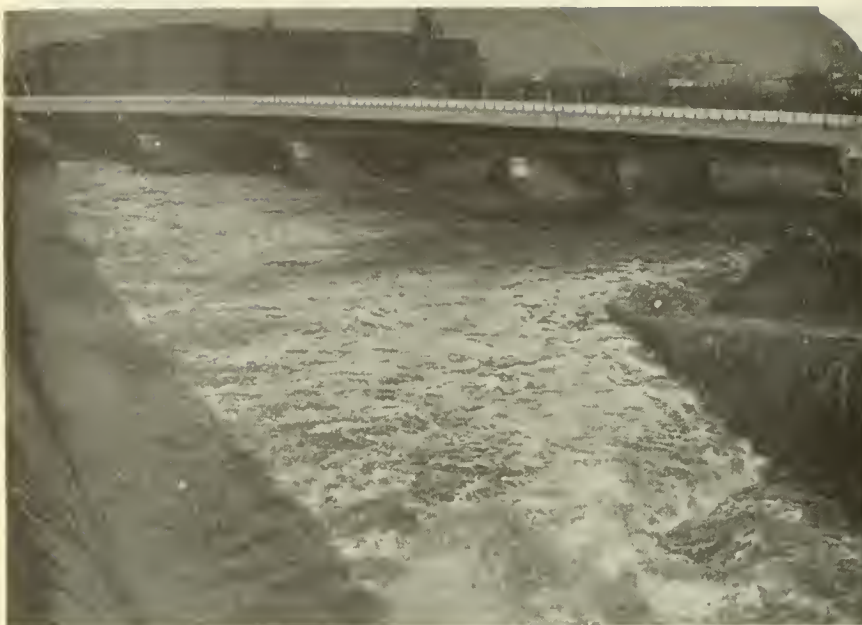
Figure 10. -- View of Lawrence Fishway Facing Downstream
Tailwater Elevation 17 ft. (above mean sea level).

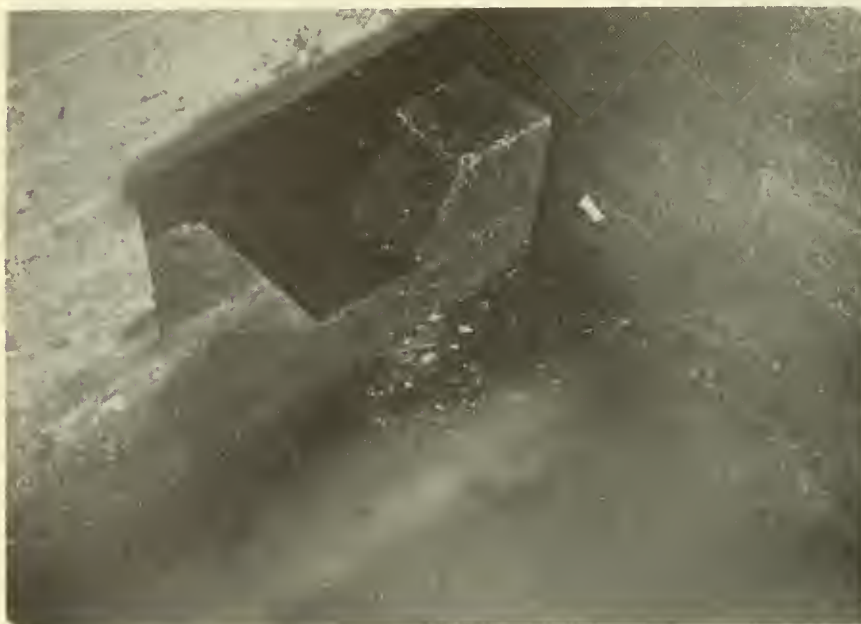
Figure 11. -- Notched Weir.
Note the unusual thickness of the weir and the sloping floor of the notch. The downstream edges of the notch have a 2-inch bevel.

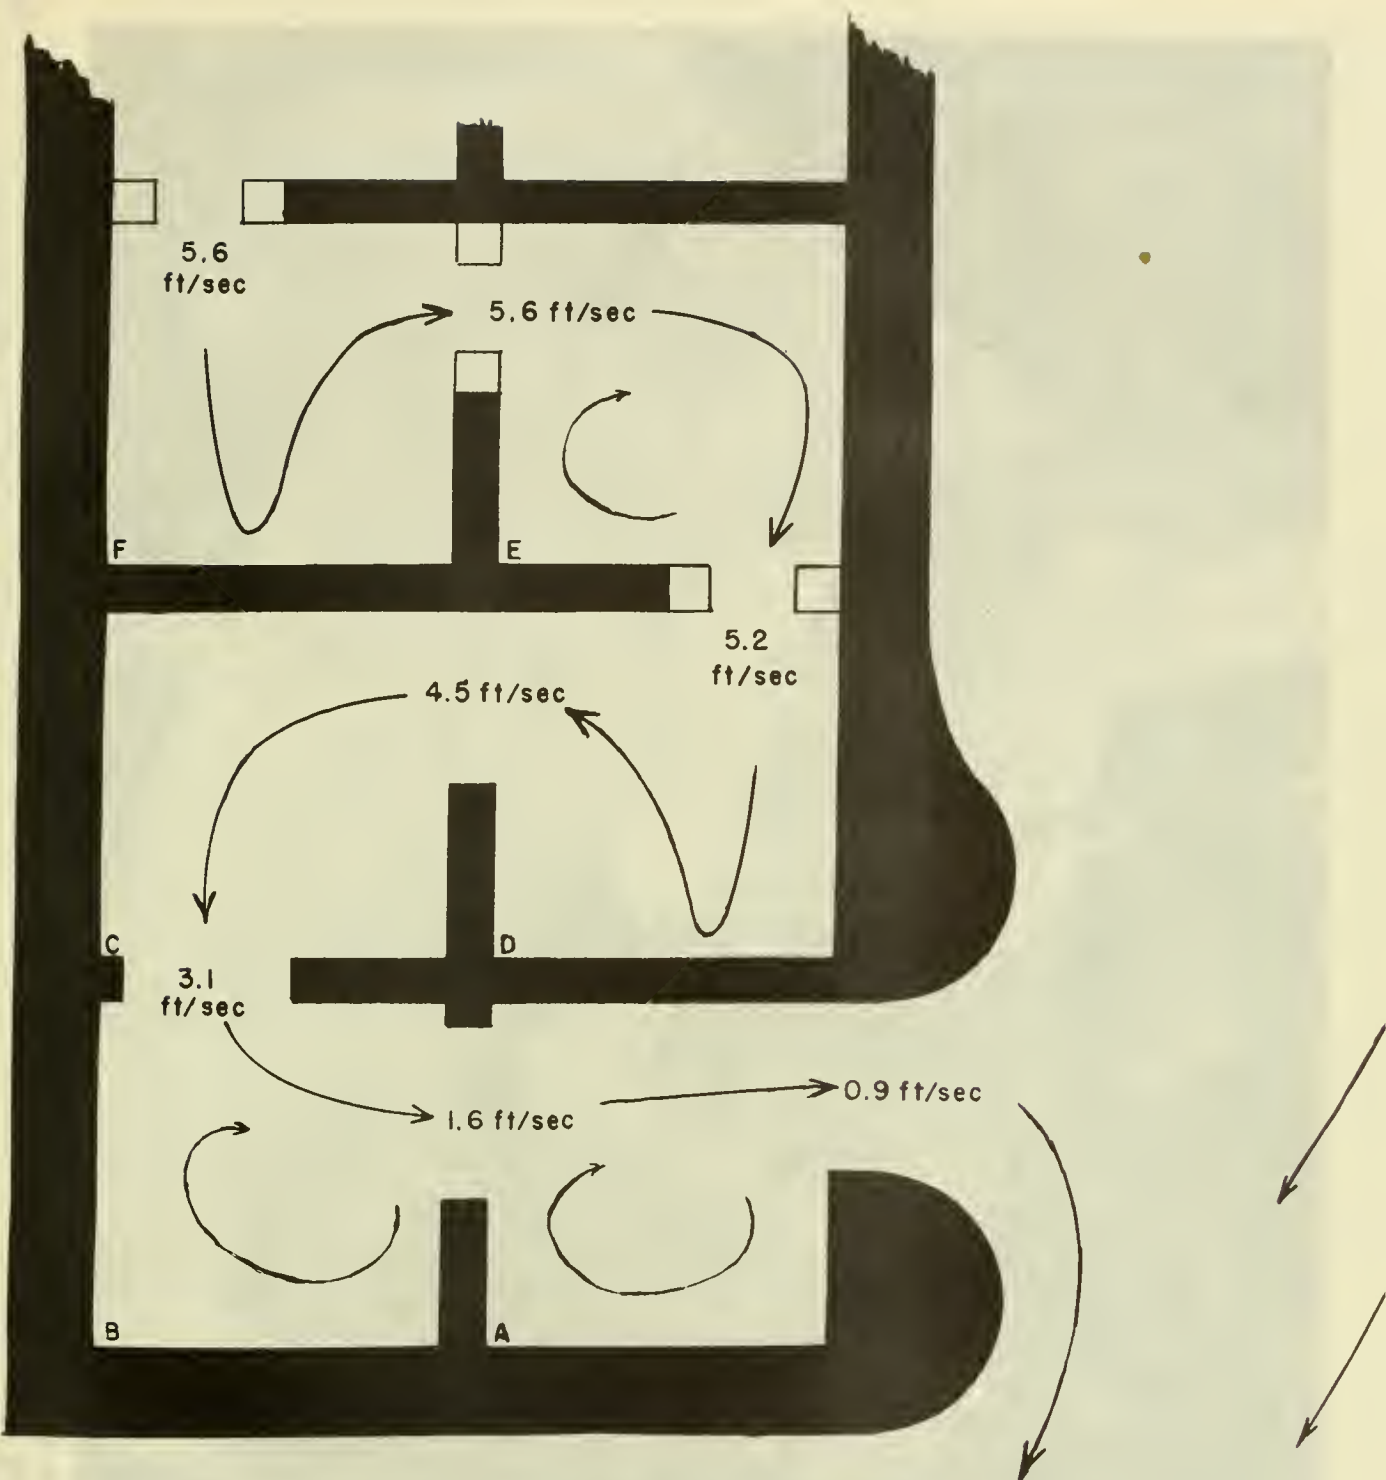
Figure 12.--Diagram of Flow Pattern in Lawrence Fishway
 Tailwater Elevation 13 ft. (above mean sea level). The velocities shown are the maximum velocities in the jet. These velocities exist for only a few inches since the jet dissipates rapidly. In pools E and F all velocities, other than in the jet, were less than 1.5 ft/sec. The arrows diagram the main flow, not surface currents. Note that the first 4 weirs are flooded. The almost 180° change in the direction of flow shown in pools D and F is an undesirable feature. It has been observed that the fish sometimes hit the wall at the turning point. Probably the low water velocities involved keep this from being a serious condition in the Lawrence Fishway.

A comparison was made of the flow patterns in the fishway pools with the two different types of weirs, the original wide weir and the notched weir with its sloping floor. The direction of the main flow (Figure 12) was approximately the same with both types of weirs, although the flow from the notched weir was much more concentrated. The greater depths created by the addition of notched weirs resulted generally in lower velocities and reduced turbulence, particularly in the lower areas of the pools. However, the maximum velocities in the jet produced by the notched weir were about 0.8 ft/sec. higher than the maximum velocities produced by the wide weir. Thus, with the notched weir, there was a much sharper contrast between the velocity of the water in the jet and the velocity of the rest of the water in the pool. With the broad weir and the shallower depth, velocities throughout the pool were more uniform. The condition at the approximately 180° change in the direction of flow in certain pools (Figure 12) is probably accentuated by the concentrated flow from the notched weirs.

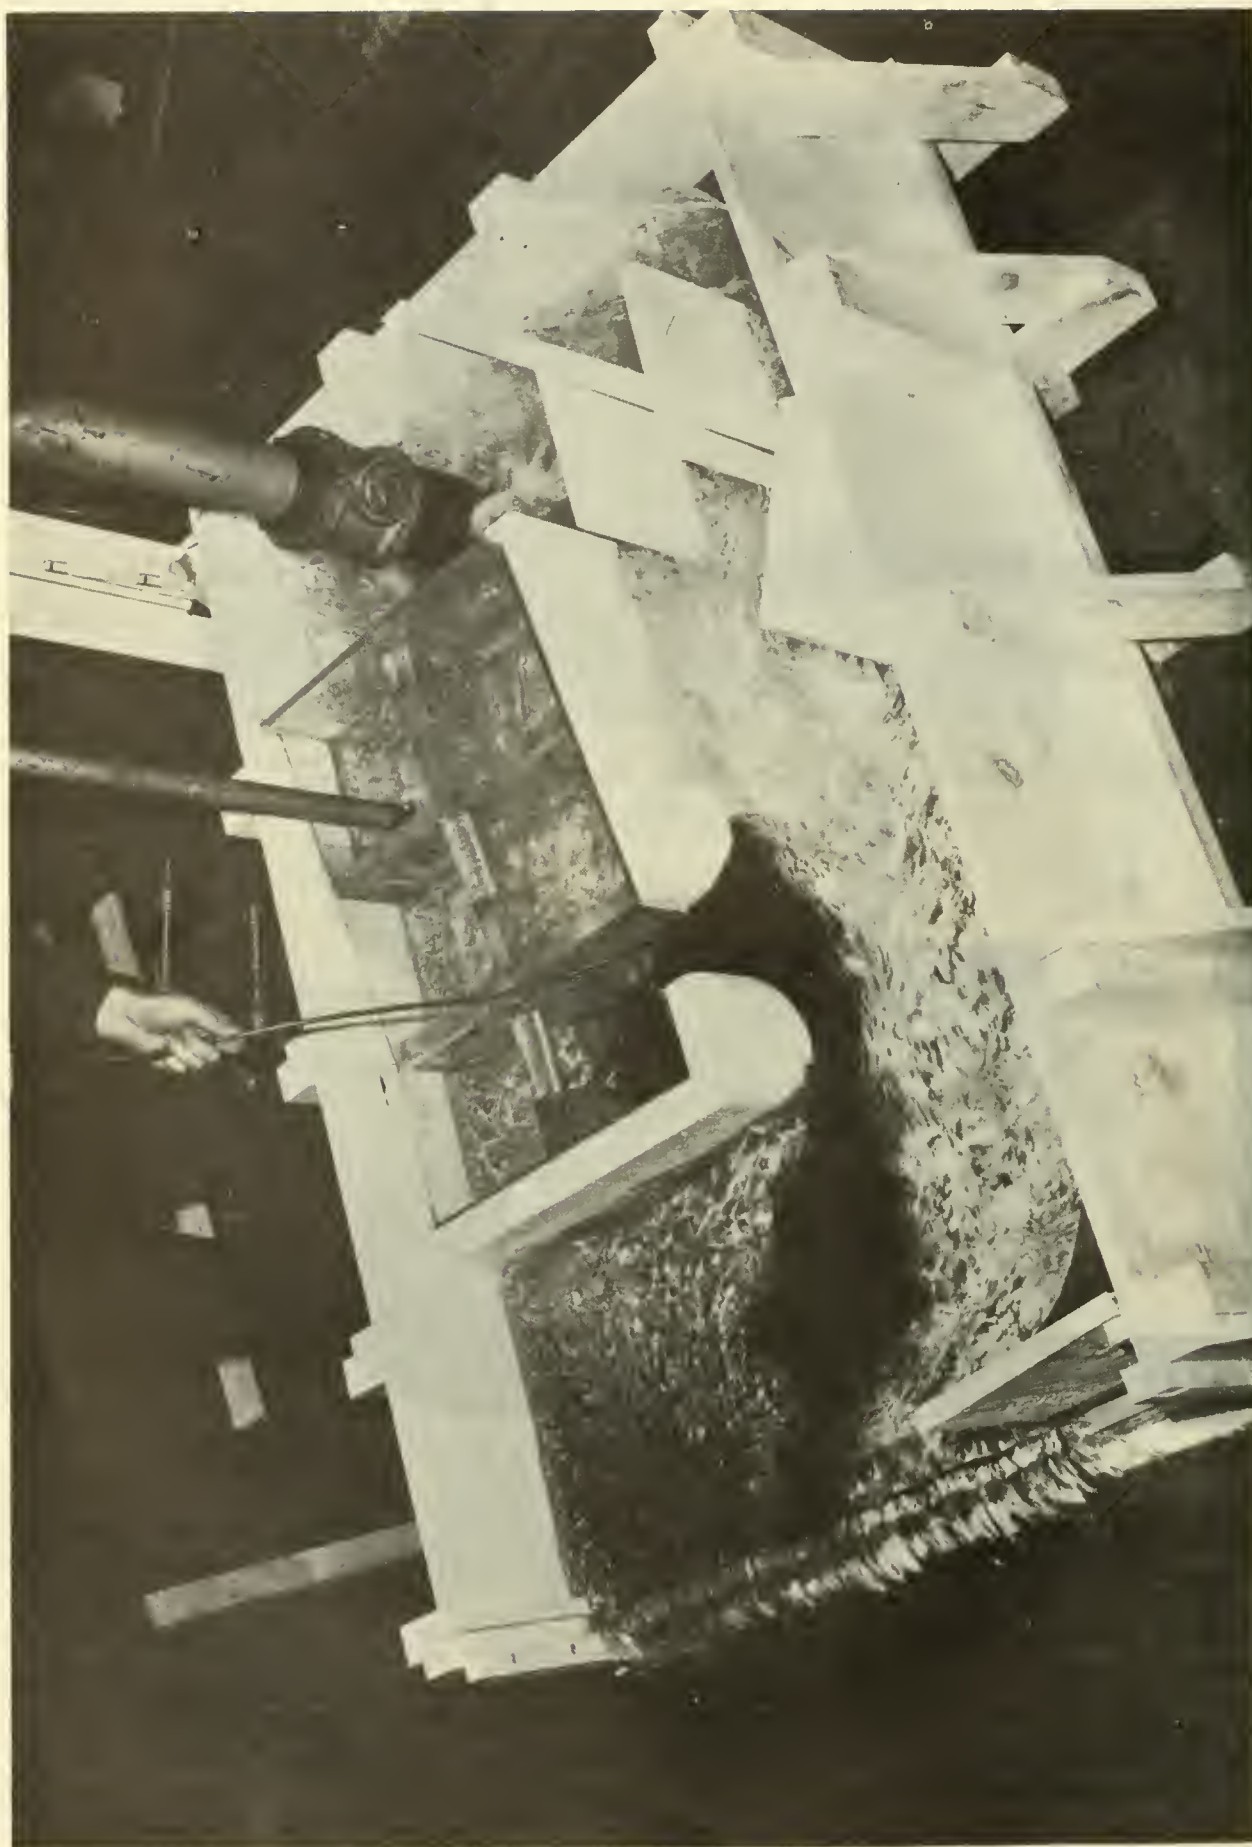
Figure 13. - General View of Fishway Model - (Alden Hydraulic Laboratory)
Tailwater Elevation 13ft. (Above mean sea level) The optimum conditions for entrance of shad into the fishway
are probably at this water level. Note area of reduced velocities at fishway entrance (black dye).

In order to examine in detail the characteristics of flow in the Lawrence fishway under varied water conditions, a plastic model of the lower six pools (Figure 13) was constructed and installed at the Alden Hydraulic Laboratory, Worcester Polytechnic Institute. The model was built according to the original plans (Figures 1 and 2) with removable inserts for the later modifications. Patterns of flow were studied by the addition of dye to the water.

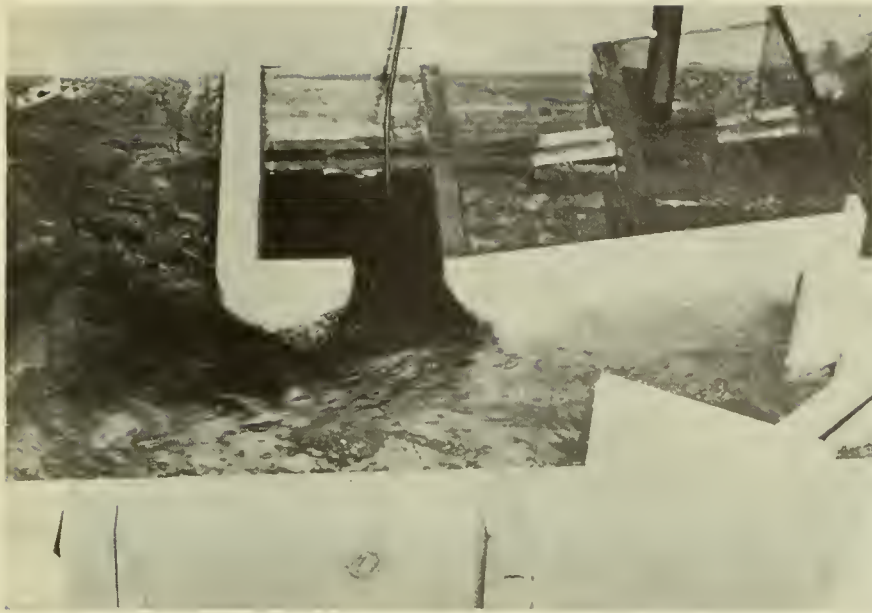
Figure 14.-- Entrance to Fishway (Model)
Tailwater Elevation 15 ft. (above mean sea level) Note flooding of weirs.

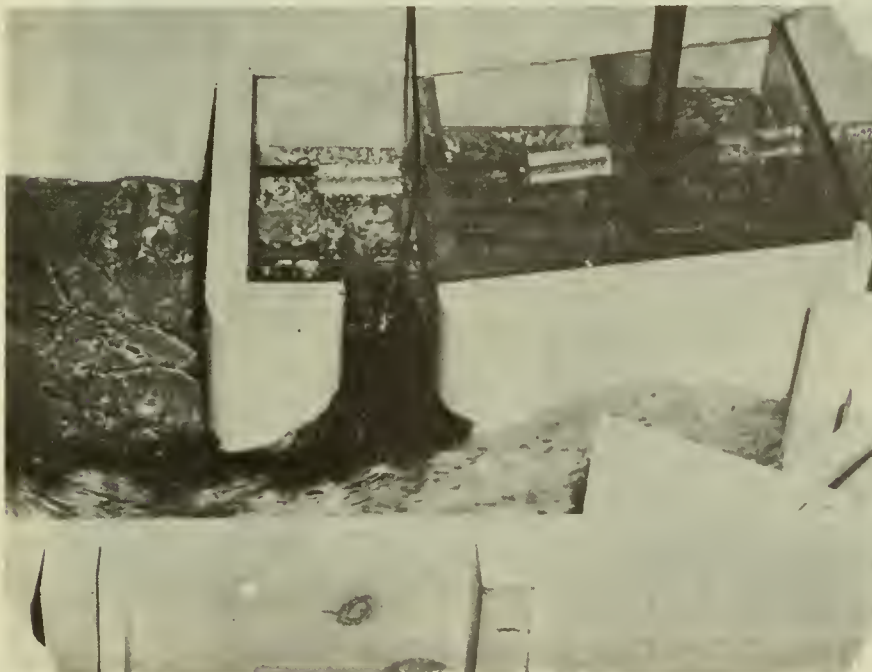
Figure 15.-- Entrance to Fishway (Model)
Tailwater Elevation 11 ft. (above mean sea level) This water level is probably close to the minimum tailwater level for entrance of shad into the fishway. Note that the first weir is flooded.

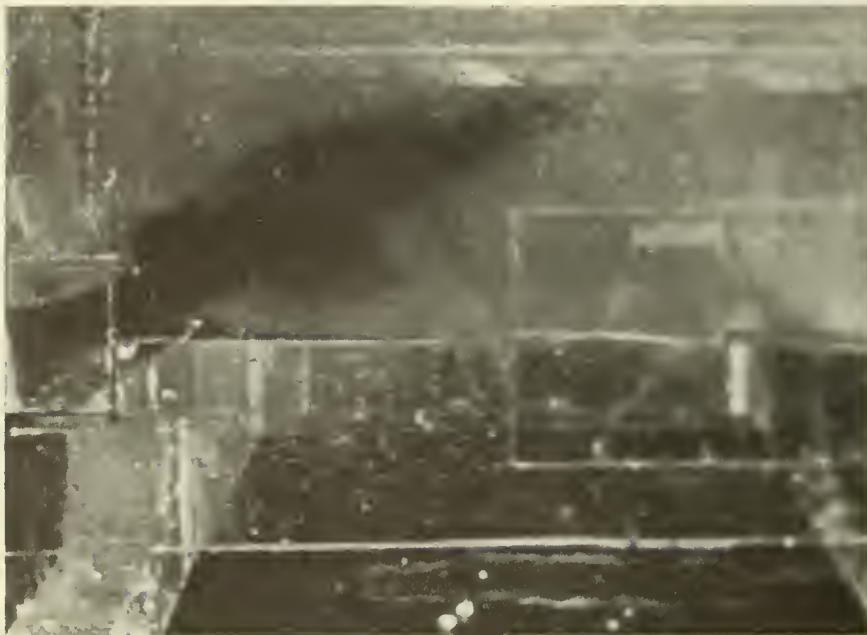
Figure 16.-- Jet from Notched Weir
(Model - Alden Hydraulic Laboratory) End view of pool E (see diagram Figure 12) of model.

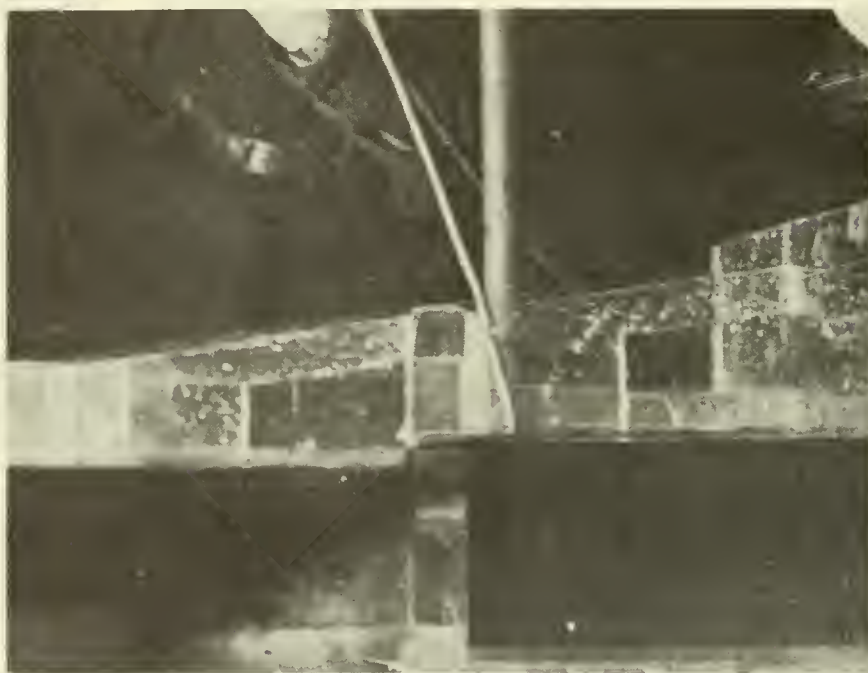
Figure 17.-- Flow through Notched Weir
(Model - Alden Hydraulic Laboratory) Side view of pools D and E (see diagram Figure 12) of model. Note that fish can swim from one pool to another (no "jump" necessary). Note also rapid divergence of jet.
